HOPKINTON RESERVOIR DAM

MA. 00437

PHASE I INSPECTION REPORT NATIONAL DAM INSPECTION PROGRAM

JANUARY 1981

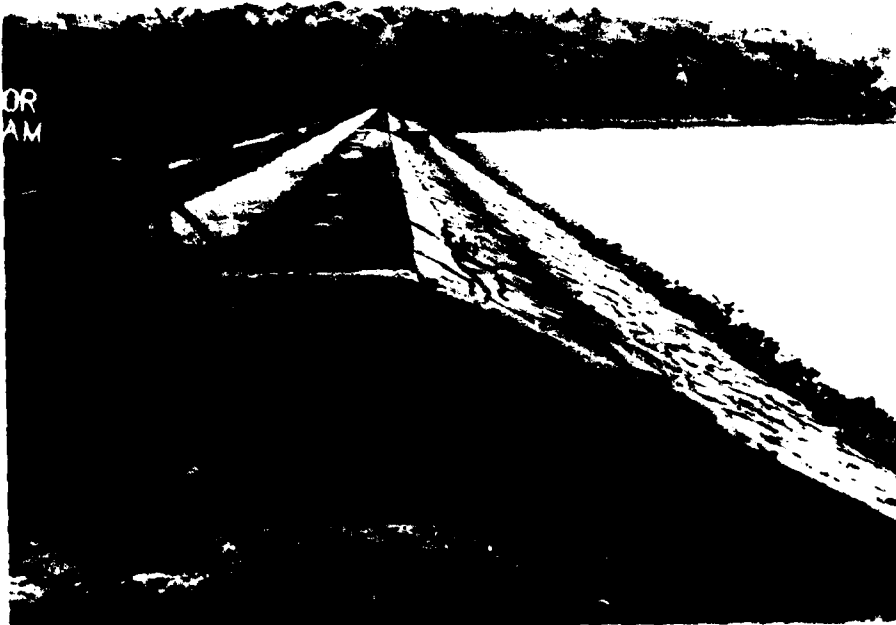
The dam is an earth embankment with a concrete core wall. It is about 1,525 ft. long, 58 ft. high and has a crest width of about 20 ft. A grass and gravel road, along the crest of the dam is in excellent condition with no evidence of erosion or settlement. The 2 horizontal to 1 vertical upstream slope is protected with hand placed granite block riprap. There is some evidence of minor spalling of the riprap blocks on the upstream slope. The downstream slope is grass covered and in good condition with the exception of some eroded footpath. There are also several small trees on the downstream slope of the embankment along the side of the right spillway training wall. At about mid-height of the downstream slope there is an 8 ft. wide berm. Above the berm the downstream slope is 2 horizontal to 1 vertical and below the berm it is 2½ horizontal to 1 vertical. The horizontal and vertical alignment of the embankment is very good (see Appendix C, Photo No's 1, 2, 3 and 4).

1. Upstream slope of dam covered with hand placed granite block.

(1) Repair voids in the riprap on the upstream slope of embankment.

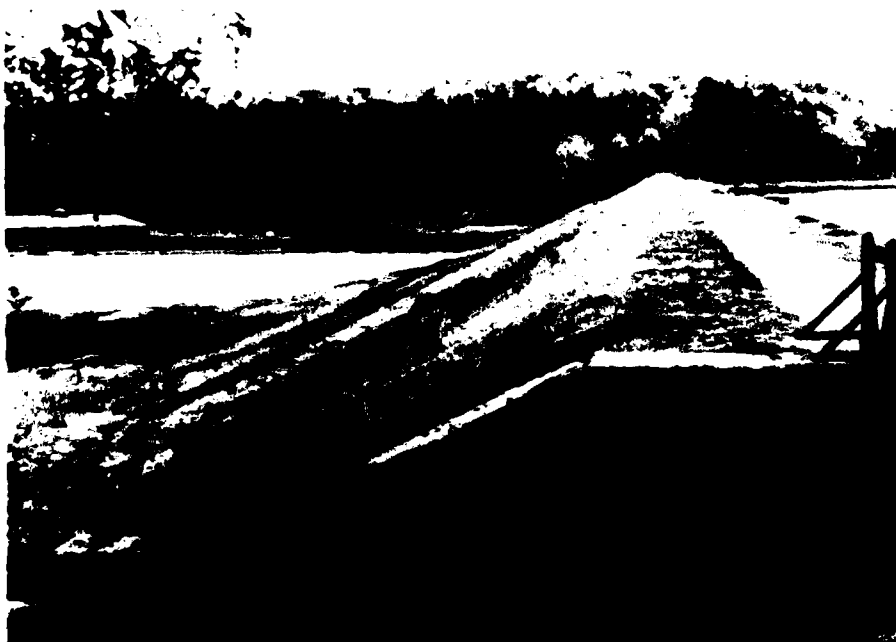
2. Downstream slope of dam

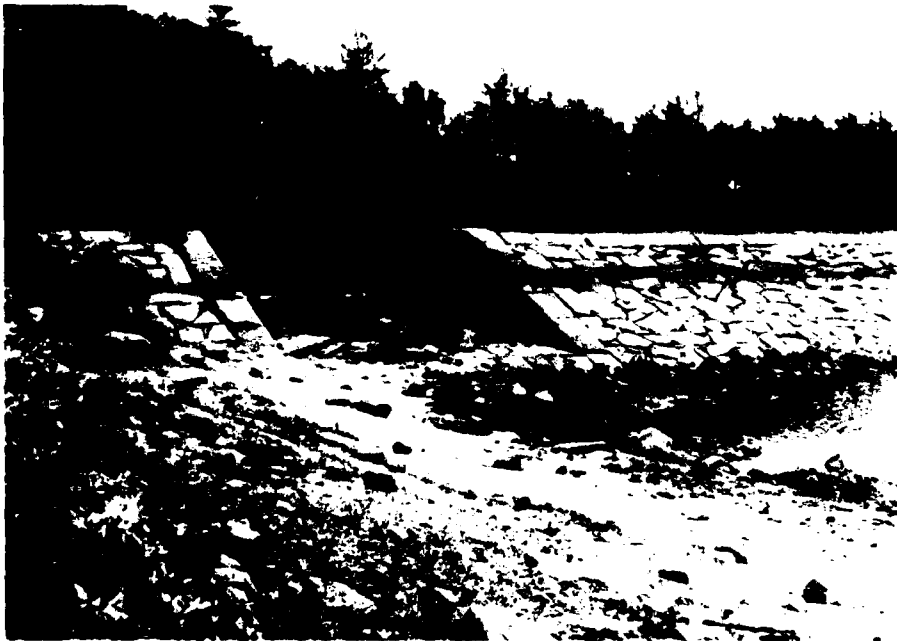
c. Appurtenant Structures. The spillway for Hopkinton Reservoir Dam is located about 20 ft. right of the left abutment. It is a 29.8 ft. long broad crested granite block, gravity structure. Granite block training walls extend 7 ft. from the spillway crest to top of dam. The spillway crest and training walls are in good condition. The spillway discharges into a 400 ft. long stepped wasteway constructed of mortared granite blocks. The wasteway empties into a 150 ft. long granite block channel with vertical concrete walls and then into a trapezoidal earth embankment channel which eventually joins the original stream. The downstream spillway discharge channel is in generally good condition with the exception of mortar missing from joints. (see Appendix C, Photo Nos. 6,7,8,9 & 10).

6. Spillway approach channel.

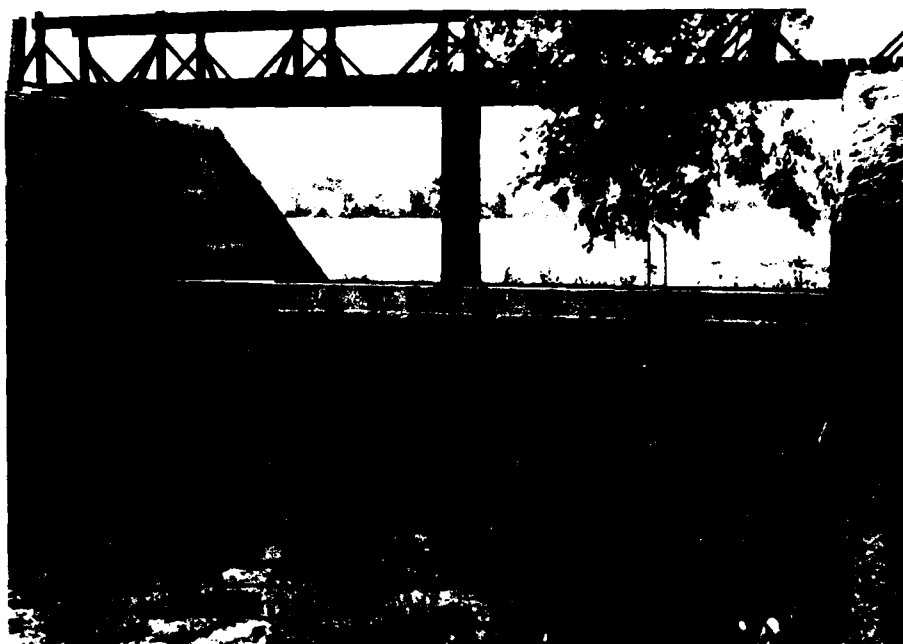
7. View of spillway from downstream channel.

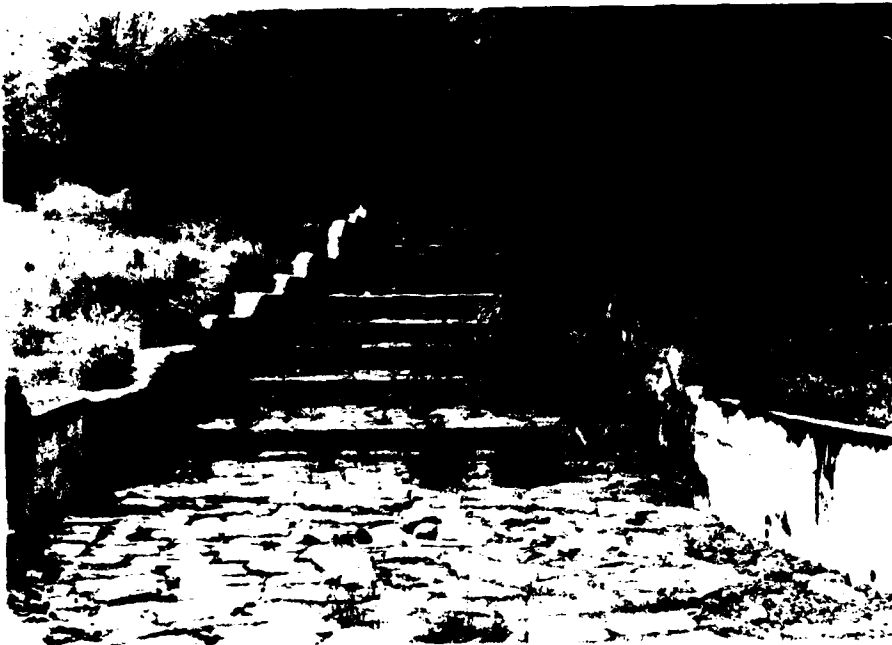
. View of spillway channel from downstream toe.

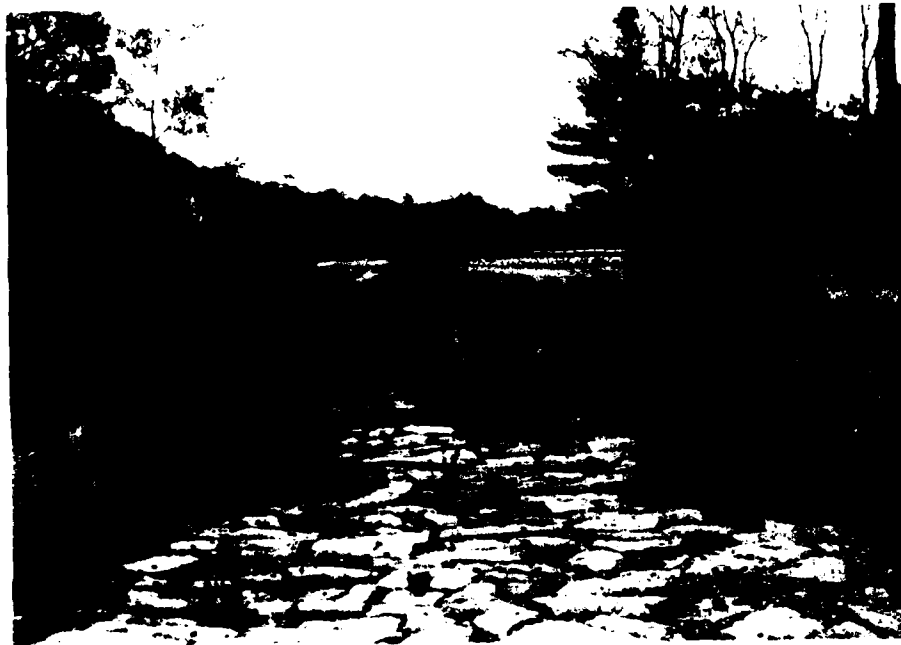
.0. Granite block and concrete channel and earth embankment channel beyond downstream toe of spillway channel.

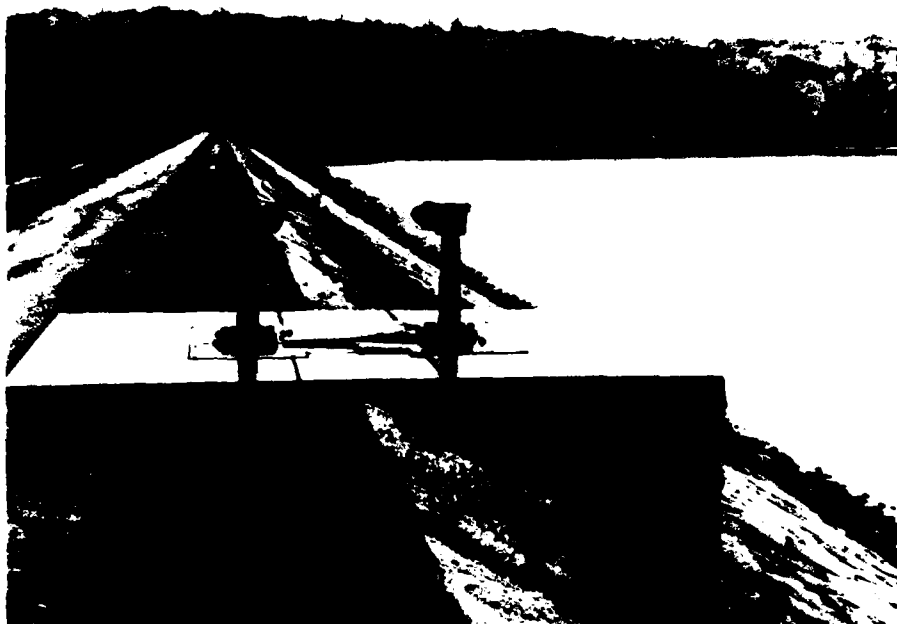
The smaller of the two low level outlets is a 36 in. dia. cast iron pipe with a 24 in. dia. stub on the downstream end. This pipe is located about 475 ft. left of the right abutment. It is controlled by a sluice gate located in a gate chamber that is operated from the crest of the dam and also has a second control near the downstream end which is a gate valve. The condition of these gates is unknown. The owners representatives did not recall the last time the gates were operated. The outlet invert elevation of the 36 in. pipe is approximately 5 ft. higher than the outlet invert-elevation of the 48 in. pipe. The elevation at the inlet end of this pipe is unknown. The 36 in. dia. pipe discharges into an earth ditch which leads to Indian Brook. (see Appendix C, Photo Nos. 11, 12, 13 & 14).

2. Left outlet gate chamber.

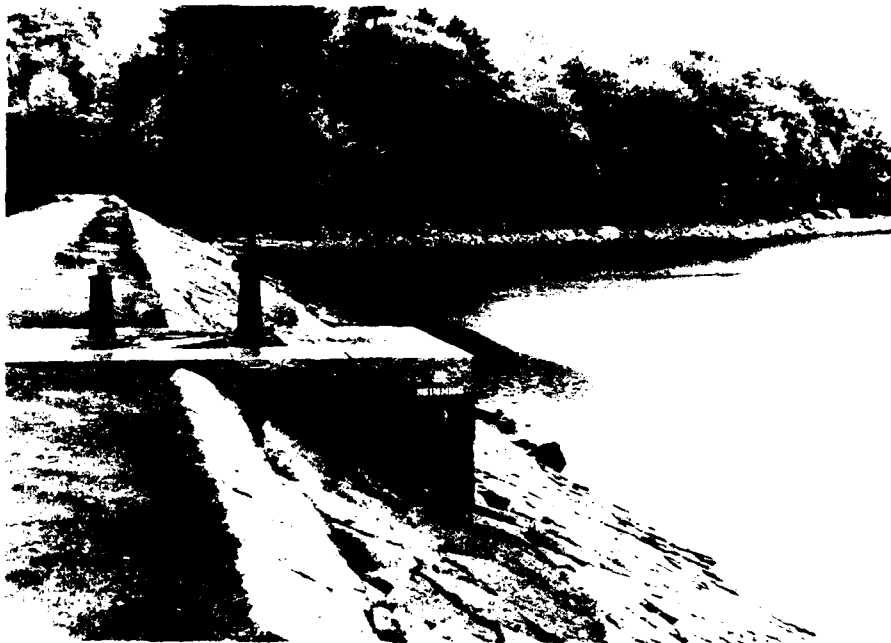
13. Right outlet gate chamber.

(9) Determine if the right outlet structure is operative and if not study the feasibility of making any necessary repairs.
